**Arana Gulch Watershed Enhancement  
Plan Phase 1:  
Steelhead and Sediment Assessments,  
Santa Cruz County, California**

February 2002

Balance Project Assignment 99005.08

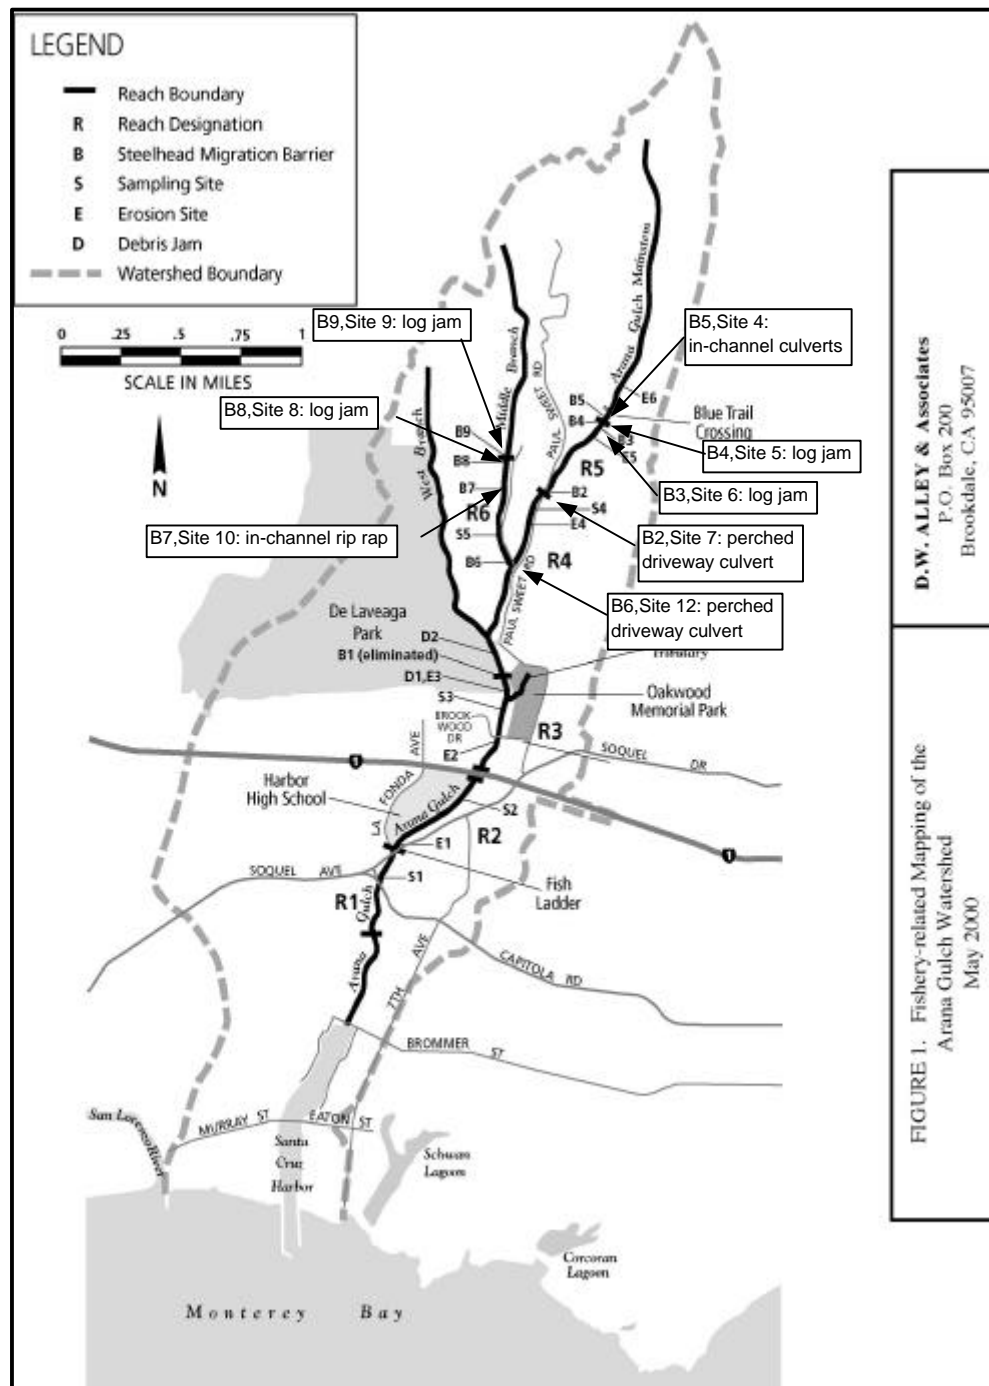
**Figure 4.1: Arana Gulch watershed with the locations of fish passage barriers, fish sampling sites and erosion sites noted.**

Channel reaches as defined for the fisheries assessment are shown. Site numbers corresponding to the Chapters 4 and 7 are also given. Map borrowed from Alley (2000). Text boxes added by Balance Hydrologics.

At each encountered streambank erosion site a rate of erosion was estimated. If erosion sites had lost an estimated 2 cubic yards of sediment per year, sites were located on the watershed map and GPS coordinates were noted. Erosion sites were categorized as landslides (1), meander cuts in which the channel was cutting into the streambank (2), log-jam diversions into the streambank (3), gullies from road runoff (4), and bank failures (5). Erosion rate was estimated. Woody debris jams were also mapped, photographed and located with GPS coordinates (where possible). The locations of streambank erosion sites and large woody debris jams are shown in **Figure 4.1**.
